Mission Bay HOA
Polson, MT

Report #: 48794-0
Beginning: January 1, 2024
Expires: December 31, 2024

RESERVE STUDY
"Full"

November 29, 2023

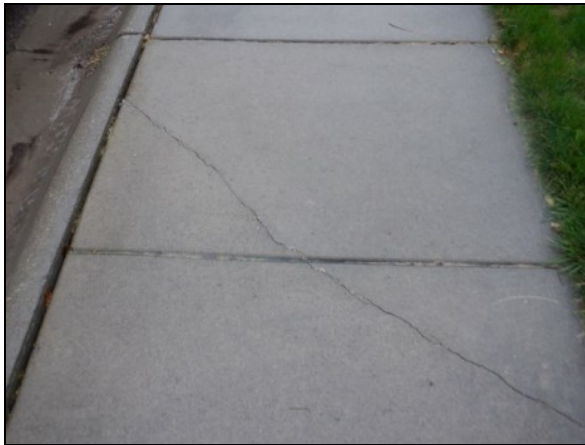
Comp #: 100 Concrete - Repair/Replace**Quantity: Sidewalks, curbs, etc.**

Comments: Localized areas of minor cracking in concrete sidewalks and curbs observed with one minor trip hazard noted just west of the community center.

The annual repair needs are below the reserves funding threshold (1% or more of total annual expenses), and should be factored into the operating budget. In our experience, as the community ages larger repair/replacement expenses may emerge that cannot be comfortably absorbed into the operating budget. Currently, it is difficult to predict the timing, scope, and costs of larger repairs. Monitor the concrete annually and if conditions deteriorate leading to larger repair needs, funding can be included within a reserve study update.

As routine maintenance, inspect regularly and pressure wash for appearance. Repair any trip hazards (1/2" difference in height) immediately to ensure safety. Repair promptly, as needed, to prevent water penetrating into the base, which can cause further damage. Factors affecting the quality and service life of the concrete include the preparation of the underlying soil and drainage, thickness and strength of the concrete used, steel reinforcement (none likely), amount and weight of vehicle traffic, and tree roots.

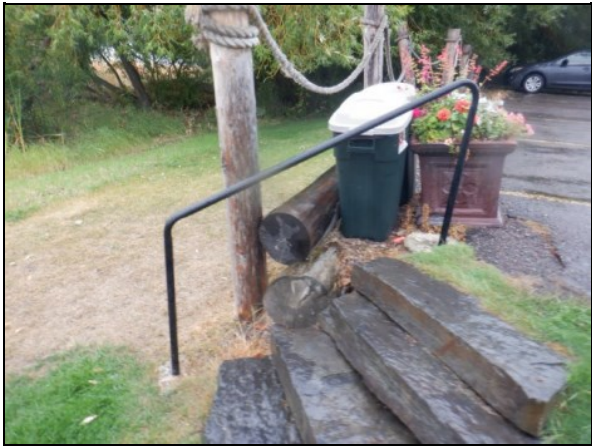
Comp #: 112 Metal Site Rail - Repair/Replace

Comments: Metal hand rail at beachfront area was fair condition with no obvious signs of instability or wear/fading to paint. As this railing is a small and should be painted/replaced as needed through the operating budget.

Routinely inspect for stability, security, and appearance. Repair locally, as needed, with operating funds.

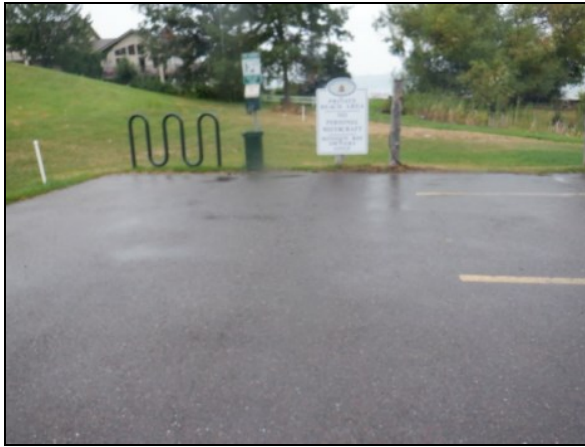
Comments: Roads generally appeared in fair condition with localized areas of crack fill, raveling, and repairs. Large areas of alligator cracking which may indicate an erosion of the underlying sub base. At this point we recommend reaching out to a civil engineering firm to determine overall life and maintenance needs moving forward.

The useful life below assumes regular repairs and seal coating (see component #121). The lack of repairs and seal coating can greatly decrease the asphalt's useful life. Resurfacing is typically one of the larger expense items in a reserve study. When the need to resurface is becoming apparent, consult with a geotechnical engineer for recommendations, specifications/scope of work, and project oversight.

As routine maintenance, keep surfaces clean and free of debris, ensure that drains are free flowing, repair cracks, and clean oil stains promptly. Assuming proactive maintenance, plan to resurface at roughly the time frame below.

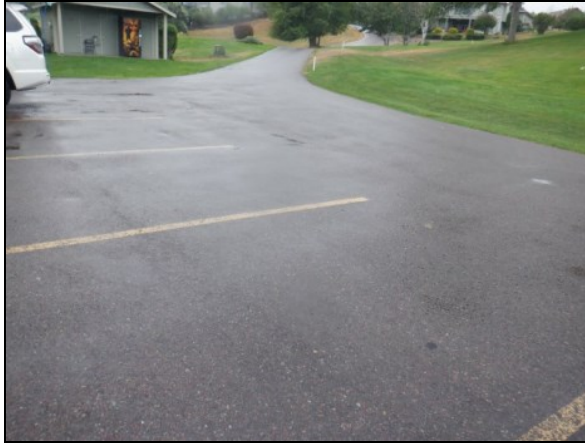
Comp #: 121 Asphalt - Repair & Seal**Quantity: ~413,000 SF**

History: 2021 Crack fill and patching ~\$13,500

Comments: Asphalt was observed with previous crack fill throughout the roads. Localized areas of structural alligator cracking observed. For the longest lasting roads we recommend regular seal coating and crack fill roughly at the timing below. At this point we recommend reaching out to a civil engineering firm to determine overall life and maintenance needs moving forward.

Repairing asphalt before seal coating is imperative. Surface preparation and dry weather during and following application is key to lasting performance.

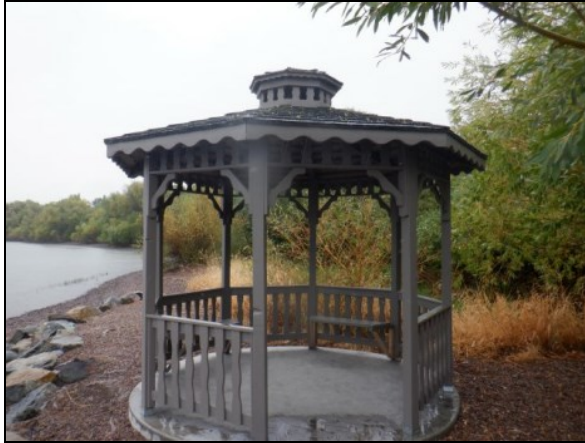
Comp #: 150 Gazebo - Repair/Replace

Comments: Gazebo is wood with painted surfaces in fair condition with no obvious signs of major instability. Roof was wood shingle roof and reported to be original to the structure. Shingles were warped and had moderate organic growth and debris from overhanging tree limbs. Roof shingles may need to be replaced ahead of refurbish timing below. Monitor regularly for missing shingles or advanced deterioration. No recent major repairs or replacements reported.

Inspect regularly, and repair as necessary utilizing operating funds. The gazebo's eventual replacement will likely become necessary around the timeframe indicated below.
