## Mission Bay Preserve *Polson, MT*

Report #: 46223-0  
Beginning: January 1, 2024  
Expires: December 31, 2024

# RESERVE STUDY "Full"

December 6, 2023

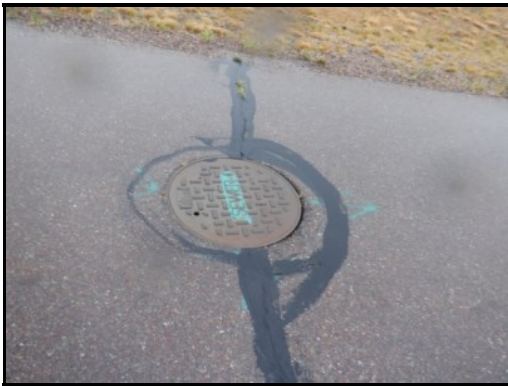
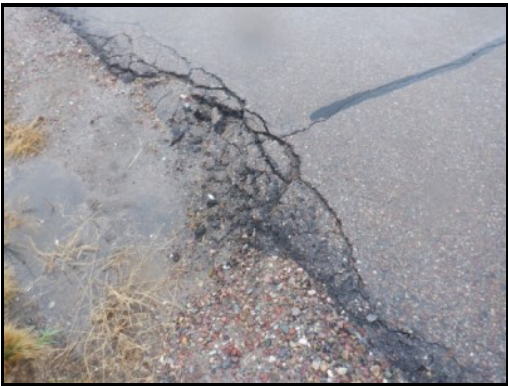
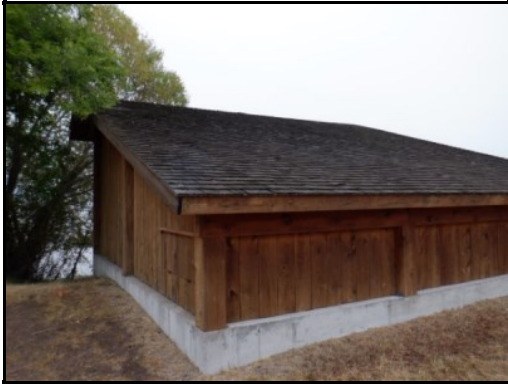
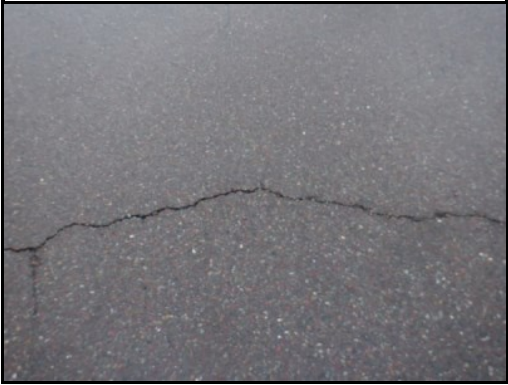
During our site visit on 8/21/2023, we visually inspected all visible common areas, while compiling a photographic inventory, noting: general exterior observations, make & model information where appropriate, apparent levels of care and maintenance, exposure to weather elements and other factors that may affect the components useful life.
