## Mission Bay Preserve *Polson, MT*

Report #: 46223-0  
Beginning: January 1, 2024  
Expires: December 31, 2024

# RESERVE STUDY "Full"

December 6, 2023

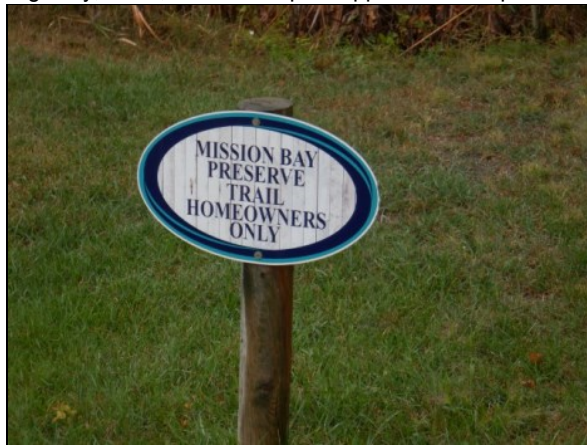
**Comp #: 191 Common Signage – Repair/Replace**

Comments: Wood signs appeared in fair condition with no major signs of instability.

As routine maintenance, inspect regularly, clean, and touch up for appearance. Repair with operating funds.

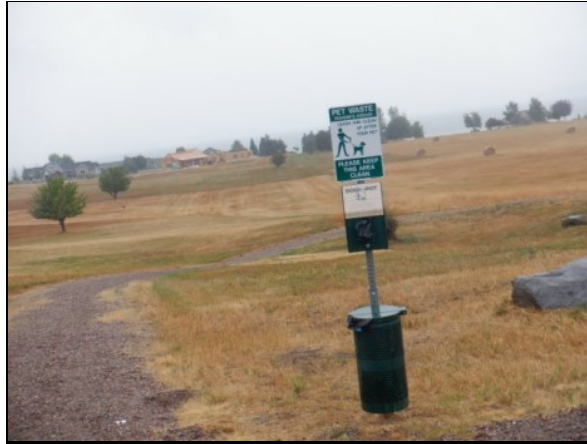
**Comp #: 194 Pet Stations - Maintain/Replace**

Comments: Pet stations adjacent to walking trail did not appear with any obvious signs of damage or instability.

Inspect regularly, stock bags, and repair/replace as needed with operating funds. If the association opts to install an extensive amount of pet stations, funding can be added to this component in future reports.

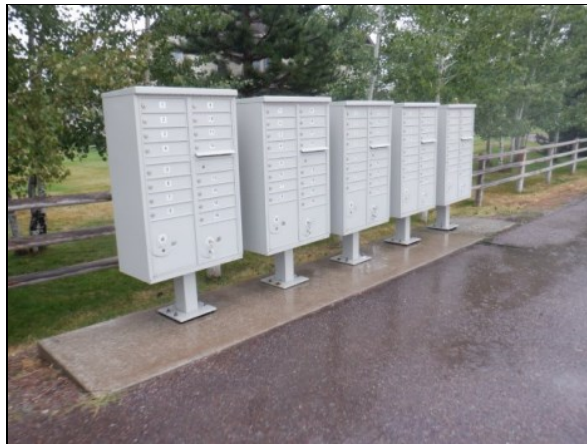
**Comp #: 195 Mailboxes - Repair/Replace**

Comments: Mailbox clusters appeared in stable condition with no obvious instability, damage, or wear noted.

In our experience, it is best to plan for total replacement at roughly the time frame below due to constant usage and wear over time.

As routine maintenance, inspect regularly, clean by wiping down for appearance, change lock cylinders, lubricate hinges, and repair as needed with operating funds.

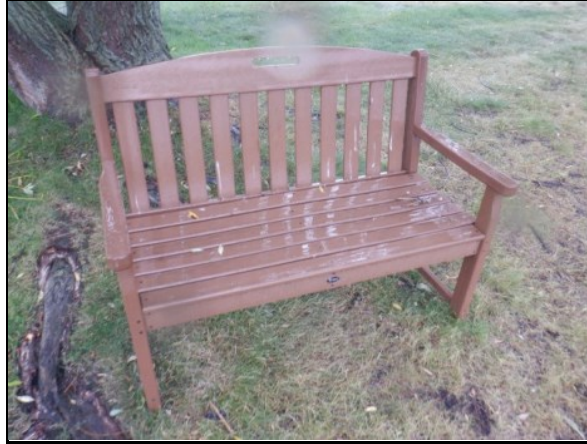
**Comp #: 346 Site Furniture - Repair/Replace**

Comments: Two trex benches one at the pond and another at the dock area in the Northeast corner of the preserve. No significant damage or decay noted.

Inspect regularly, and repair as needed with operating funds. Clean with an appropriate cleaner (refinish if desired) using operating funds.

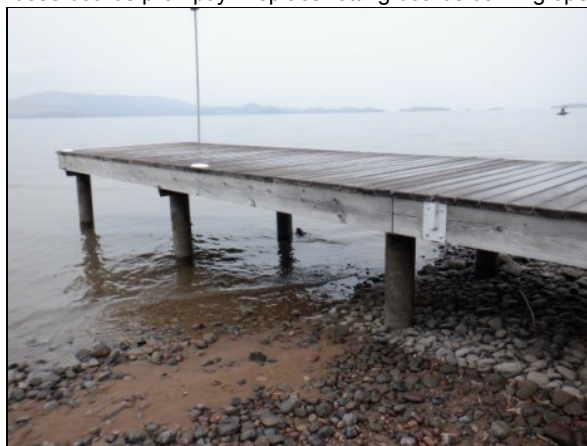
**Comp #: 360 Dock - Repair/Replace**

History: 2017 Stringer and Decking Replacement ~\$10,000; ~2003 Build

Comments: Decks appeared in fair condition with no major widespread rot or deterioration observed. Plan on major repairs roughly at the timing below.

Due to exposure to the weather elements, replacement of the surface boards should be anticipated around the time frame indicated below. The funding factored below is for replacing the existing walking surface materials with like-kind materials. The costs may be greater if the structural framing and/or pilings are found to need repair or replacement.

Inspect regularly, and repair any loose boards promptly. Replace rotting boards utilizing operating funds.

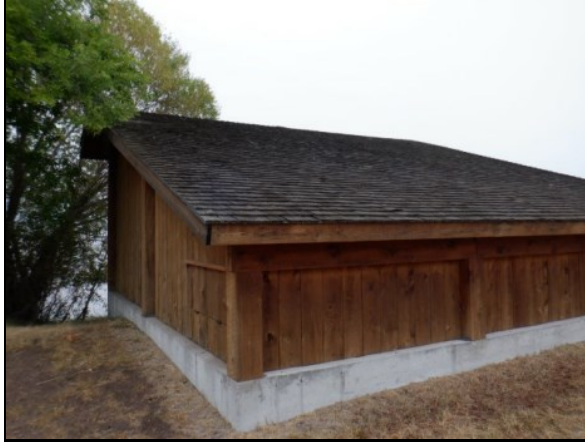
**Comp #: 504 Wood Kayak Storage - Repair/Refurb.**

Comments: Building was large wooden open structure with wooden shingle roof and wooden siding and was on open roof system. A reserve study conducts only a limited visual review, and many of the critical waterproofing and ventilation items of the roof are not readily viewable. Roof wood shingles appeared aged with minor organic growth and minor warping observed throughout. Wood structure appeared in fair condition with no major warping or deterioration noted.

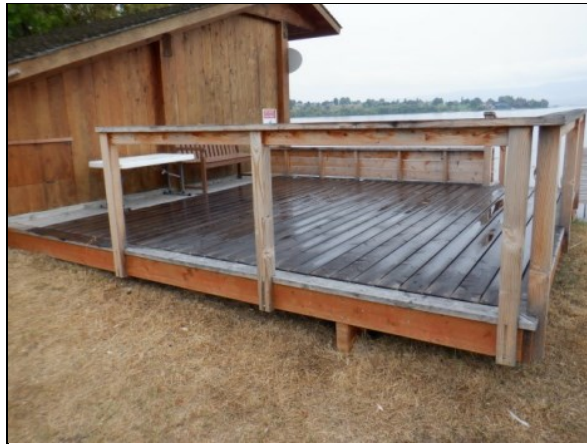
**Comp #: 546 Wood Deck - Repair/Replace**

Comments: The deck surface has open boards that allow water to drain between them. The wood deck has 2 inch boards on top of structural framing. The wood deck surface is not painted or stained. No obvious signs of damage or instability noted at this time.

The funding factored below is for replacing the existing walking surface materials with like-kind materials. The costs may be greater if the structural framing is found to need repair or replacement.
